36th WEDC International Conference, Nakuru, Kenya, 2013

**Piloting ecological sanitation (EcoSan) in the emergency
context of Port-au-Prince, Haiti, after the 2010 earthquake.**

A. Kilbride, S. Kramer & N. Preneta, Haiti

BRIEFING PAPER

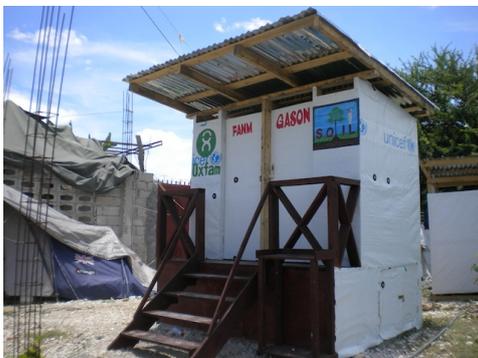
Photograph 1. SOIL UD Toilet, Jan 2011.

The first toilets built in March 2010 were constructed in a camp of approximately 2500 people. The first toilet was identical to the double vault systems in northern Haiti except that a 55-gallon drum was placed beneath the toilet seat in the chambers to allow collection and offsite treatment. The second toilet was similar dimensions but was constructed with wood and plastic sheeting (Photograph 1) in place of cement blocks. Toilet seats were brought in from South Africa. The one-month testing period revealed a number of issues, which were addressed in subsequent models. In response to feedback from the camp residents and SOIL staff all toilets constructed after March 2010 had the following modifications:

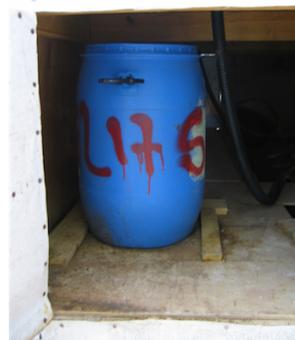
Photograph 2. 15-gallon drum with wooden guides.

- 15-gallon drums in place of 55-gallon drums, to facilitate transport and emptying (Photograph 2).
- Locally produced fibreglass UDT seats (Photograph 3)
- Guides in the chamber below the toilet seat to ensure that the drums are placed directly beneath the seat (Photograph 2).
- Non-separating drum-based toilets for children who had difficulty adapting the UDT seat (Photograph 4).

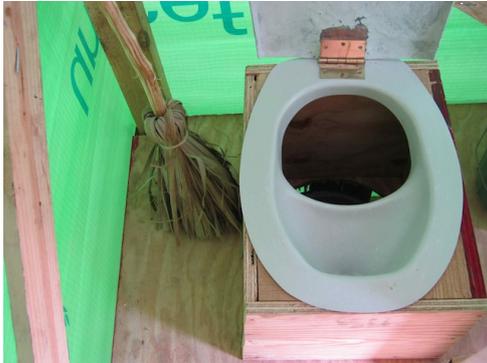
Photograph 3. Fibreglass UD seat made in Port au Prince

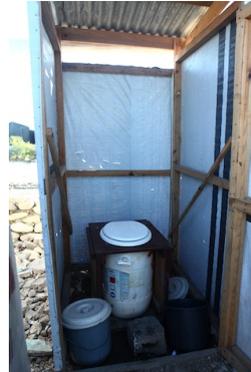
Photograph 4. Non-separating children's compost toilet
